New York Department of Environmental Conservation
Division of Environmental Remediation
Region 9 Office-Buffalo

FIELD INSPECTION REPORT

Site Name: Tonawanda Coke Plant Site

Purpose of Inspection: Respond to a spill complaint of the release of petroleum products from equipment and vehicles used on the property. In attendance during the inspection were Bob Kolvek and Pat Cahill representing Tonawanda Coke. Also in attendance during the inspection were Michael Hodanish and Larry D'Andrea of the EPA - Edison Office, who conducted a SPCC inspection of the facility.

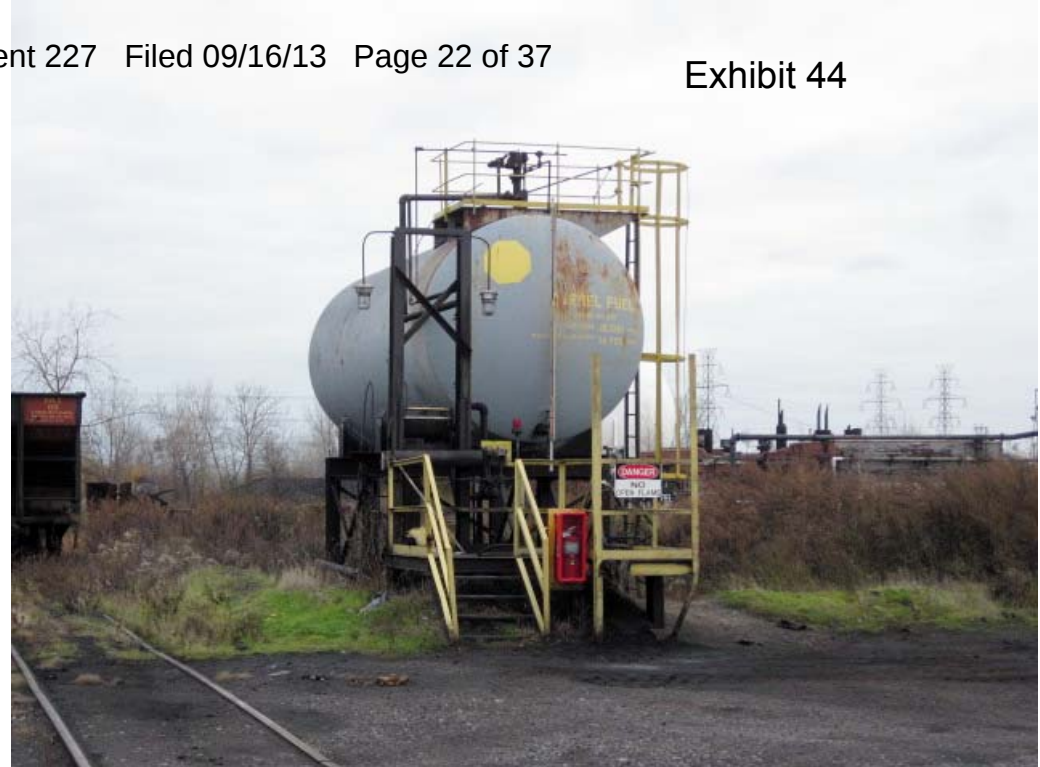
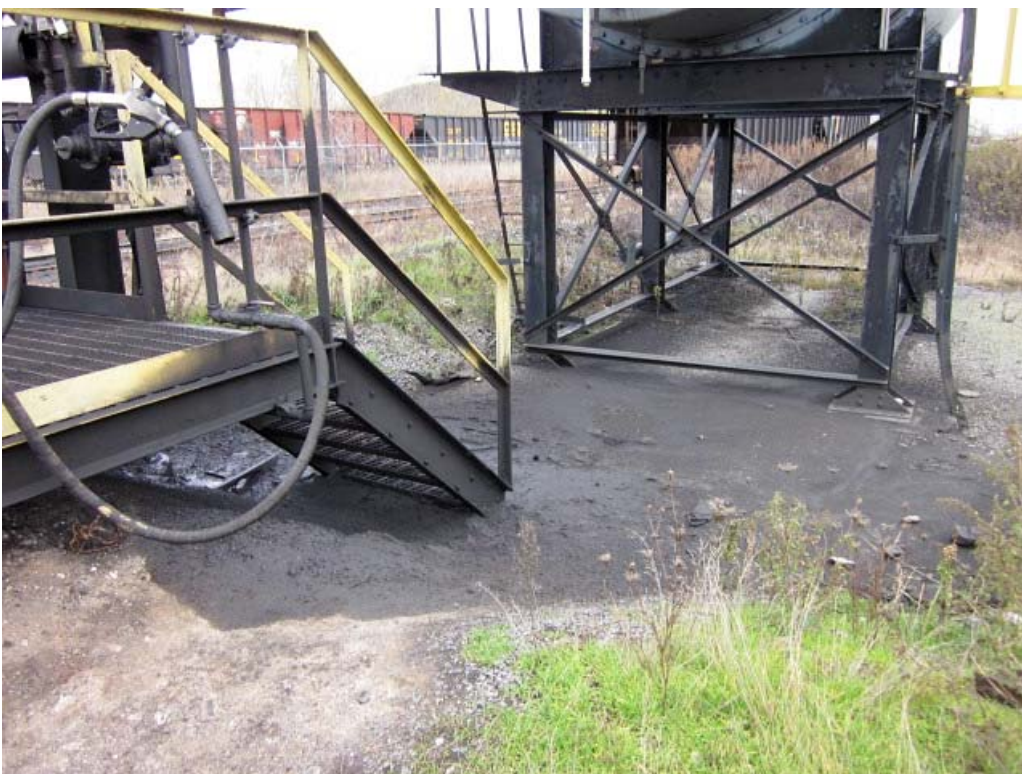
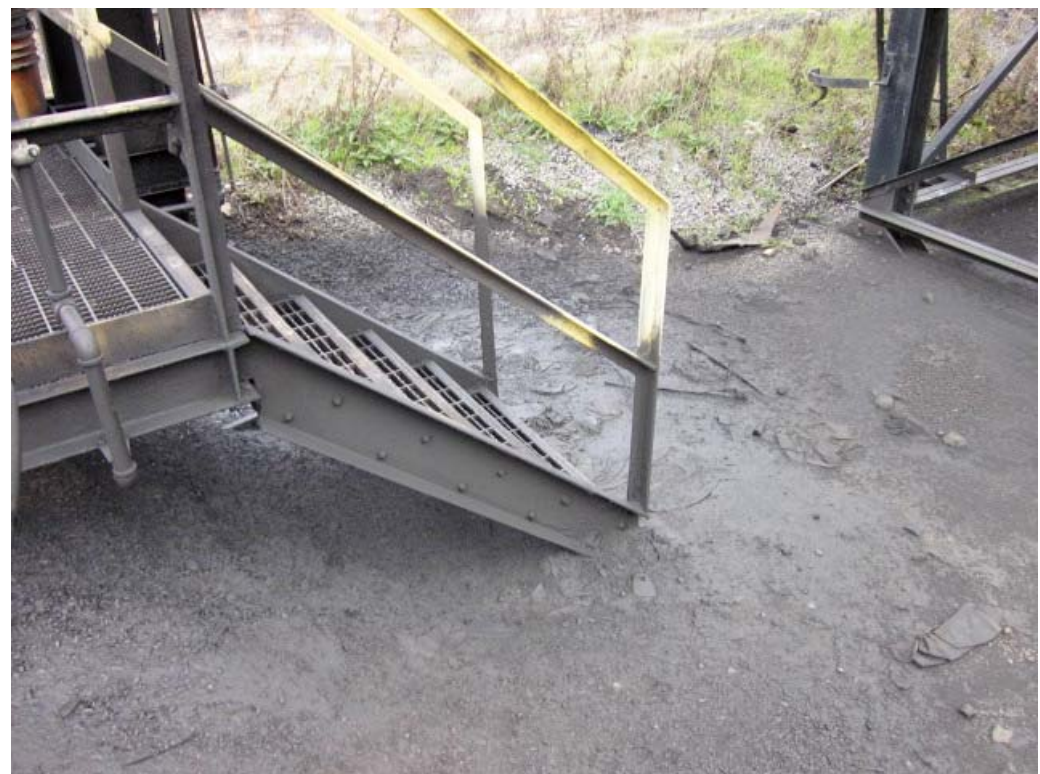
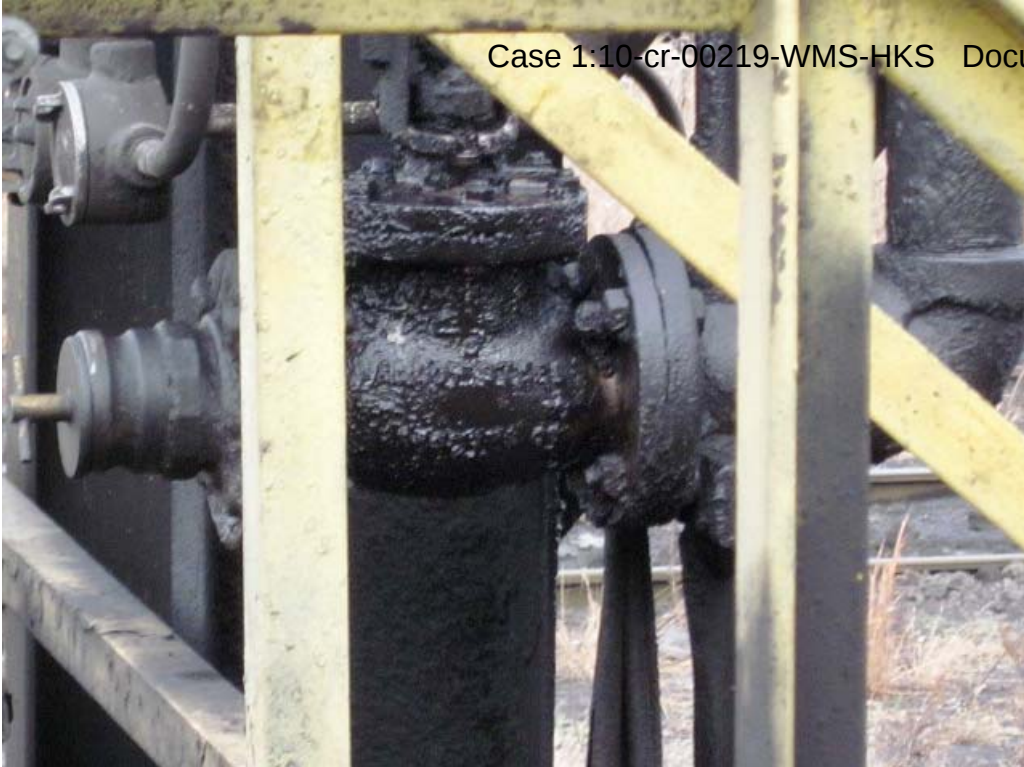
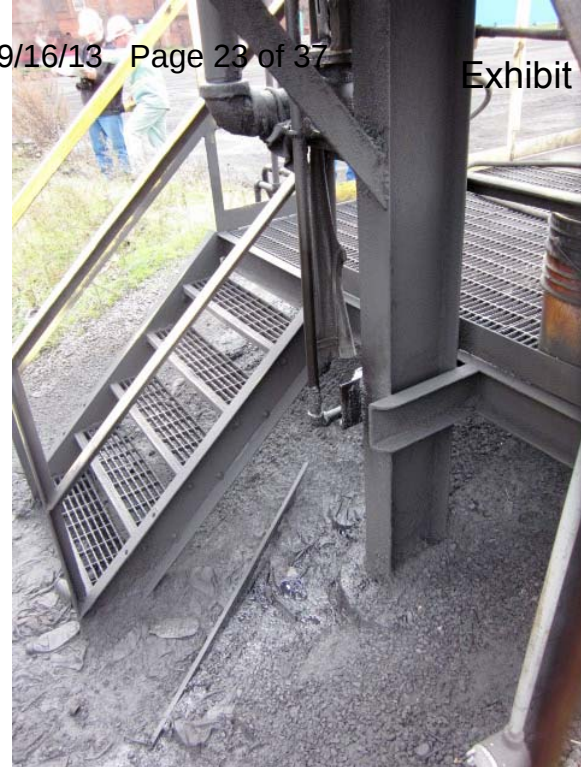
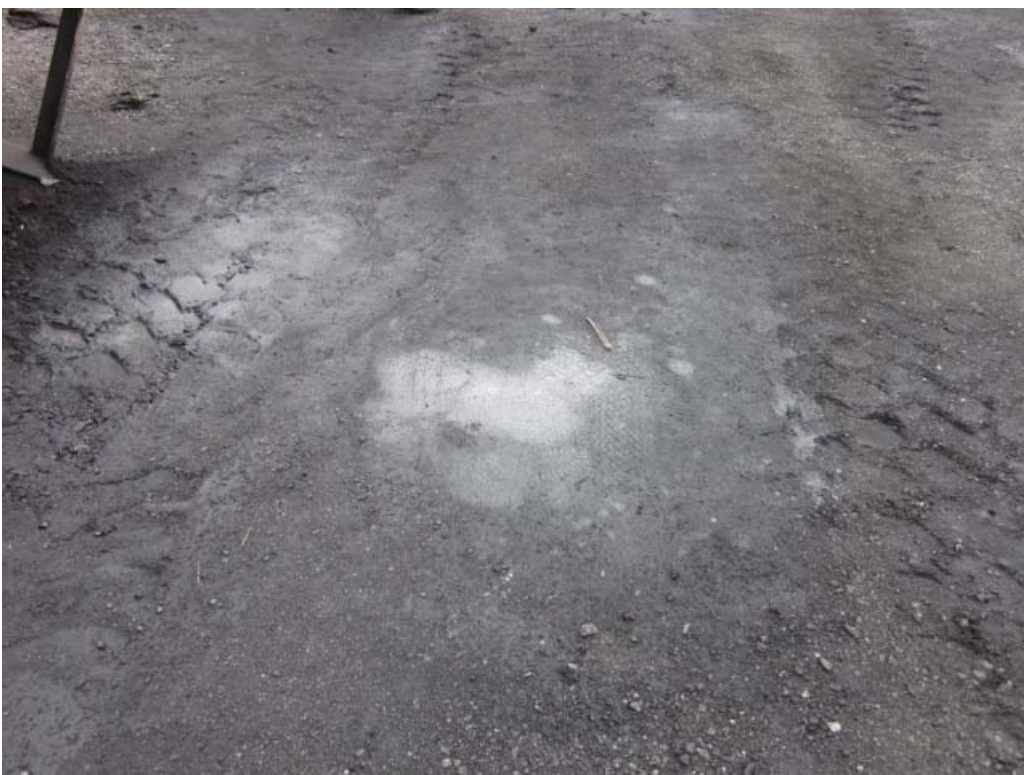
Observation: Two releases were noted during the inspection in the area of diesel fuel storage area. The tank in this area consists of a 14,700 gal. capacity AST and was labeled as containing diesel fuel (image.sp1207205.2012-11-14.4-DieselFuelTank1.jpg). Spilled fuel was observed in the area of the fuel area where the vehicles are parked during the fueling process. (image.sp1207205.2012-11-14.4-SpillInFuelingArea.jpg). There is no impermeable surface in this area so the release is directly to the ground. There is also a leaking valve on the storage tank (image.sp1207205.2012-11-14.4-LeakingValve.jpg & image.sp1207205.2012-11-14.4-DieselFuelTank2.jpg), resulting in a constant drip to the area within the containment berm which is made from coal/coke fine material (image.sp1207205.2012-11-14.4-DieselFuelTankContainmentSpillArea.jpg). The fuel was soaking into the site fill coke/coal fines material and there was no water within the containment area so it is doubtful that this area consists of non- permeable materials as required by PBS regulations for facilities exceeding 1,320 gallons capacity (image.sp1207205.2012-11-14.4-SpillInContainmentArea.jpg). Secondary containment is a requirement of several different federal and state regulations, specifically Part 112 of Title 40 of the Code of Federal Regulations and Parts 610, 613 and 614 of Title 6 of the New York State Code of Rules and Regulations.

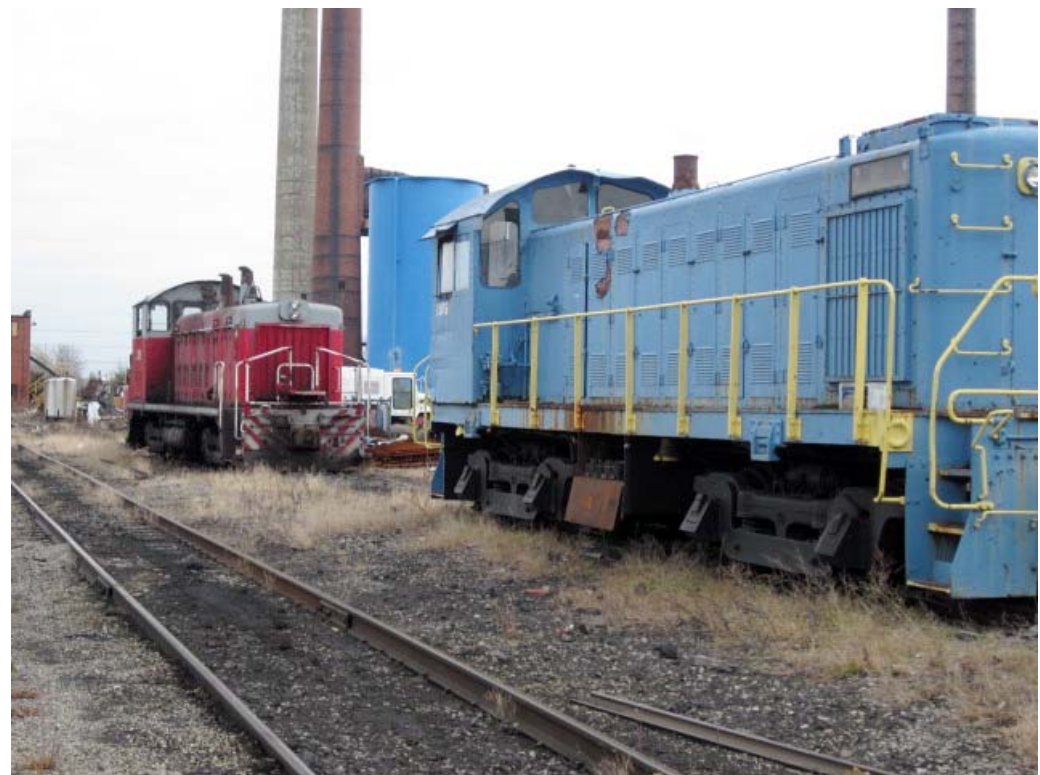
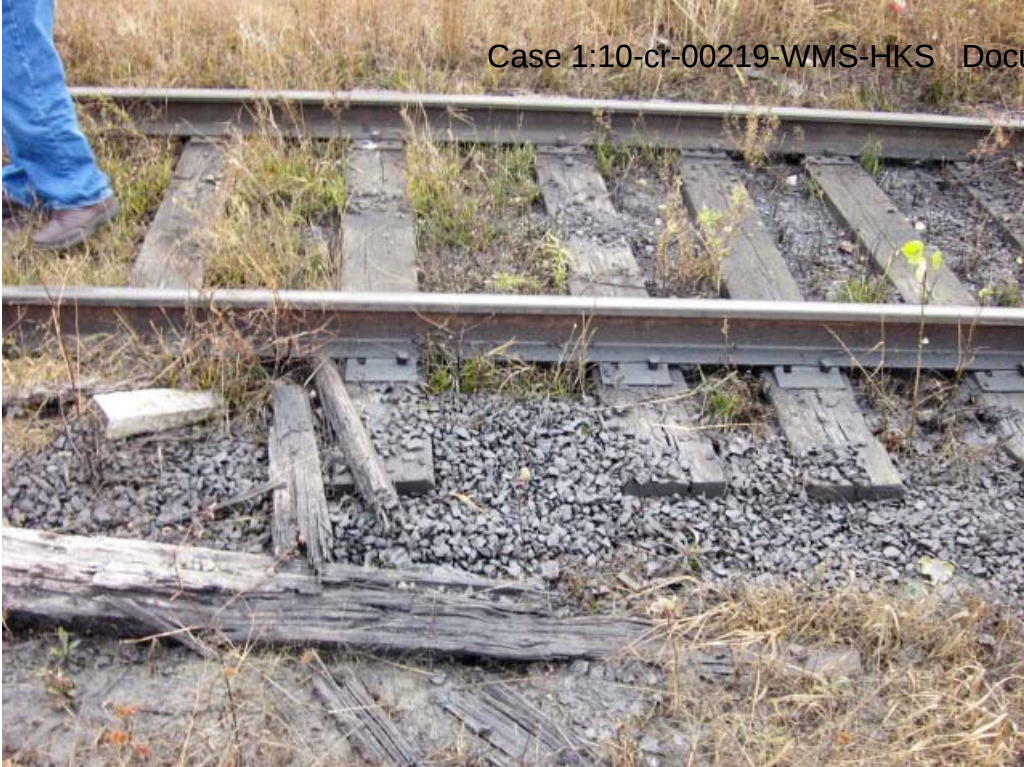
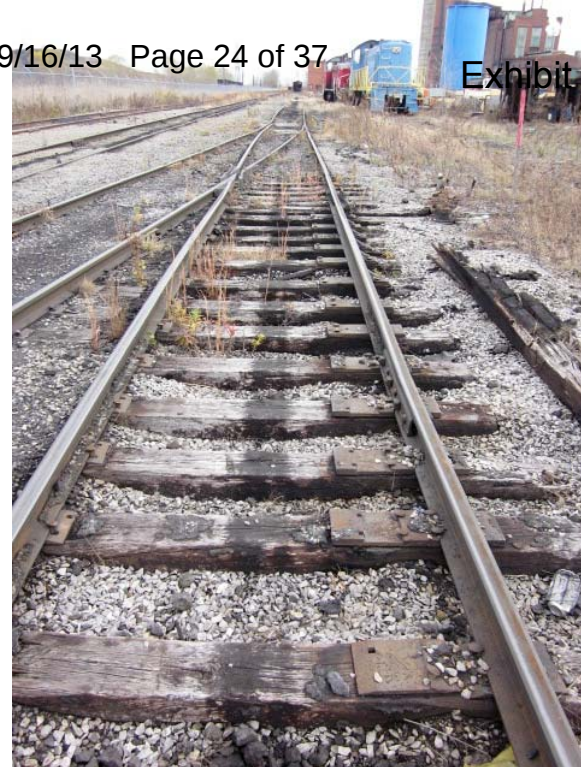
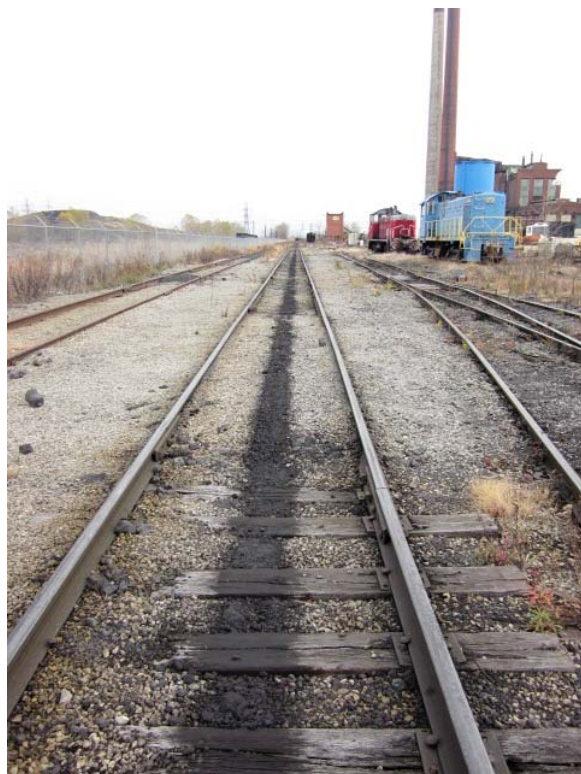
Observation: Both a Green & Red train engine were parked on a siding along the north end of the facility (image.sp1207205.2012-11-14.5-Red-BlueEngines.jpg). TCC staff indicated that both units were out of service. No spillage was observed from either unit however; the tracks in this area were noted to be severely stained from historical releases from these or other locomotive equipment previously used at the site (image.sp1207205.2012-11-14.5-RR_TrackStaining2.jpg, image.sp1207205.2012-11-14.5-RR_TrackStaining3.jpg & image.sp1207205.2012-11-14.5-RR_TrackStaining4.jpg).

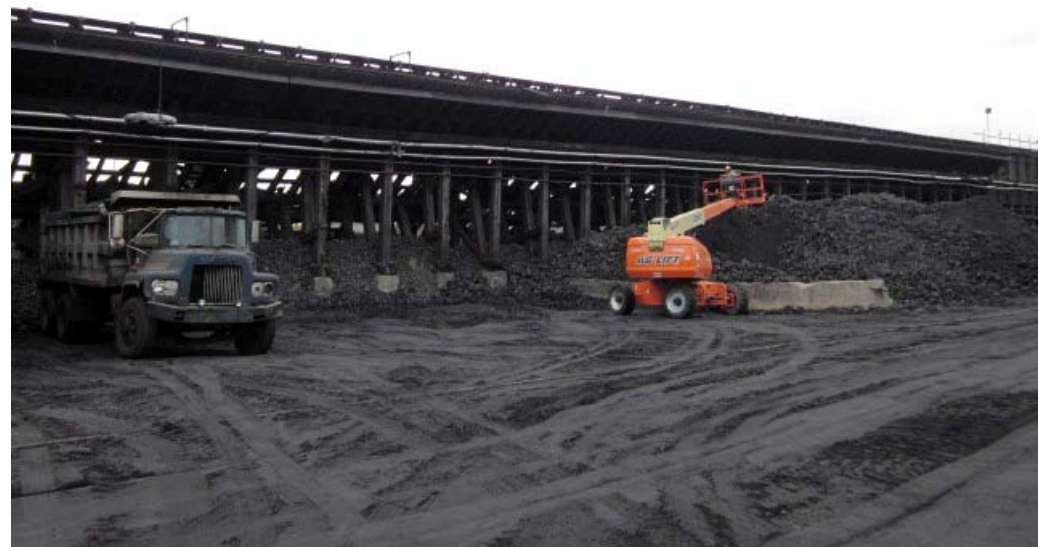
image.sp1207205.2012-11-14.6-WodenTressleArea.jpg

Observation: Due to the excessive spillage of coke/coal fines material around the structure, no petroleum releases were observed in this area during the inspection (image.sp1207205.2012-11-14.6-WodenTressleArea.jpg).

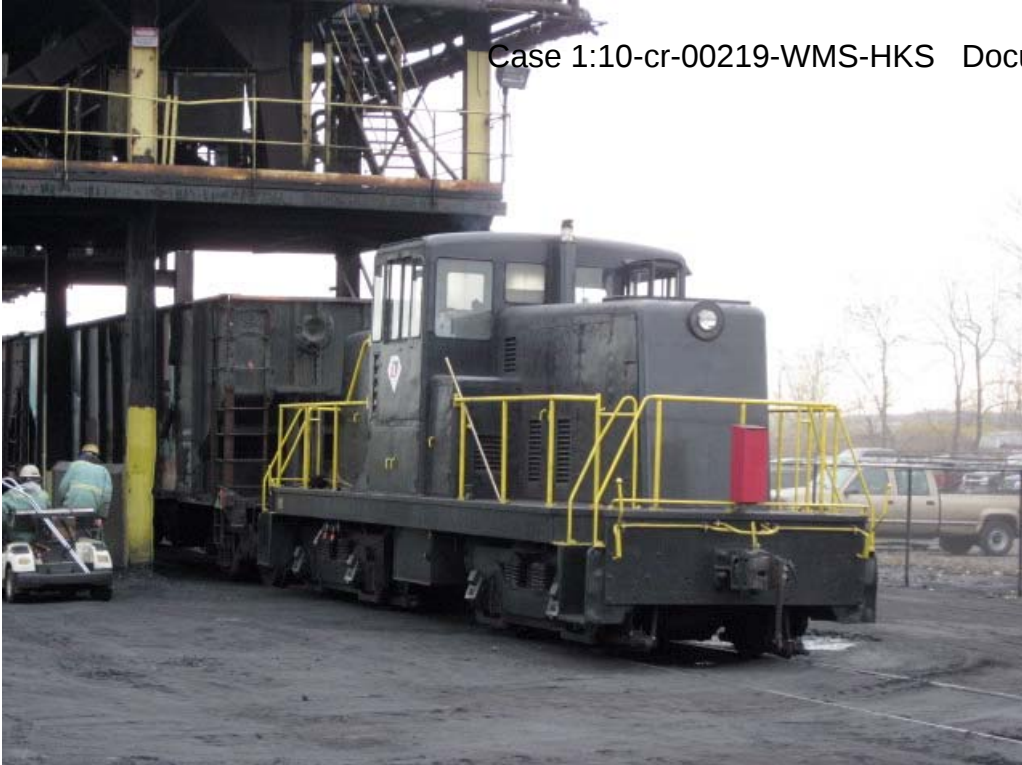
image.sp1207205.2012-11-14.7-BlackEngine.jpg

Observation: The locomotive was in operation at the time of inspection. No obvious leakage was observed from this piece of equipment (image.sp1207205.2012-11-14.7-BlackEngine.jpg).

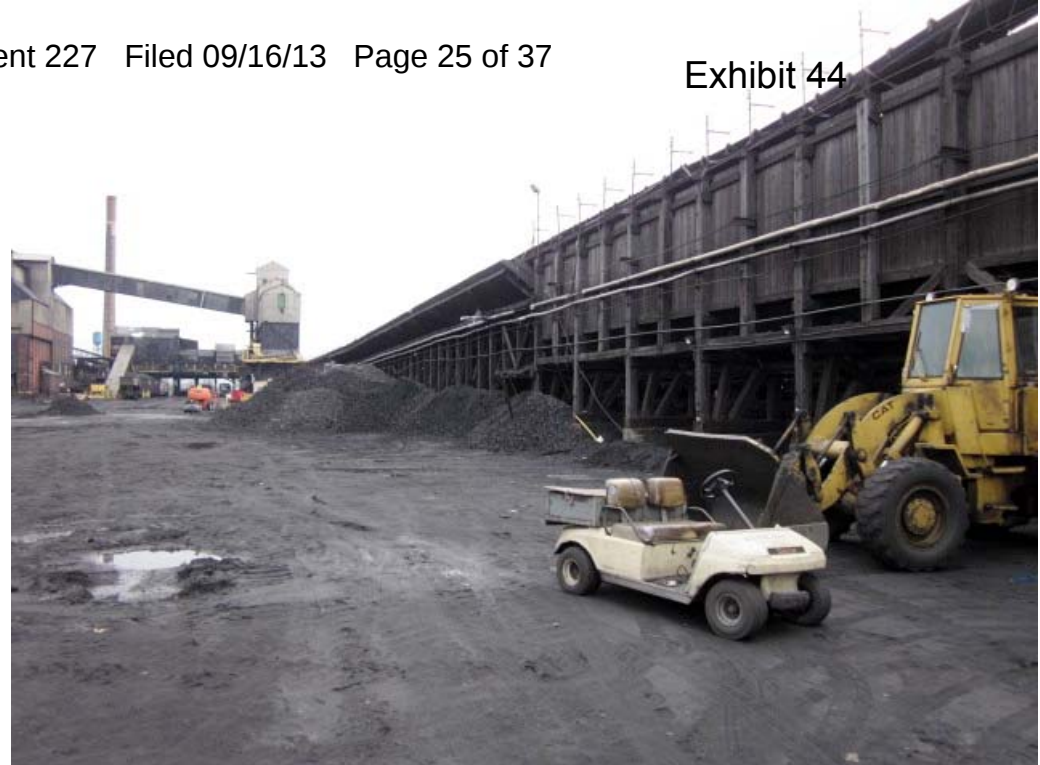
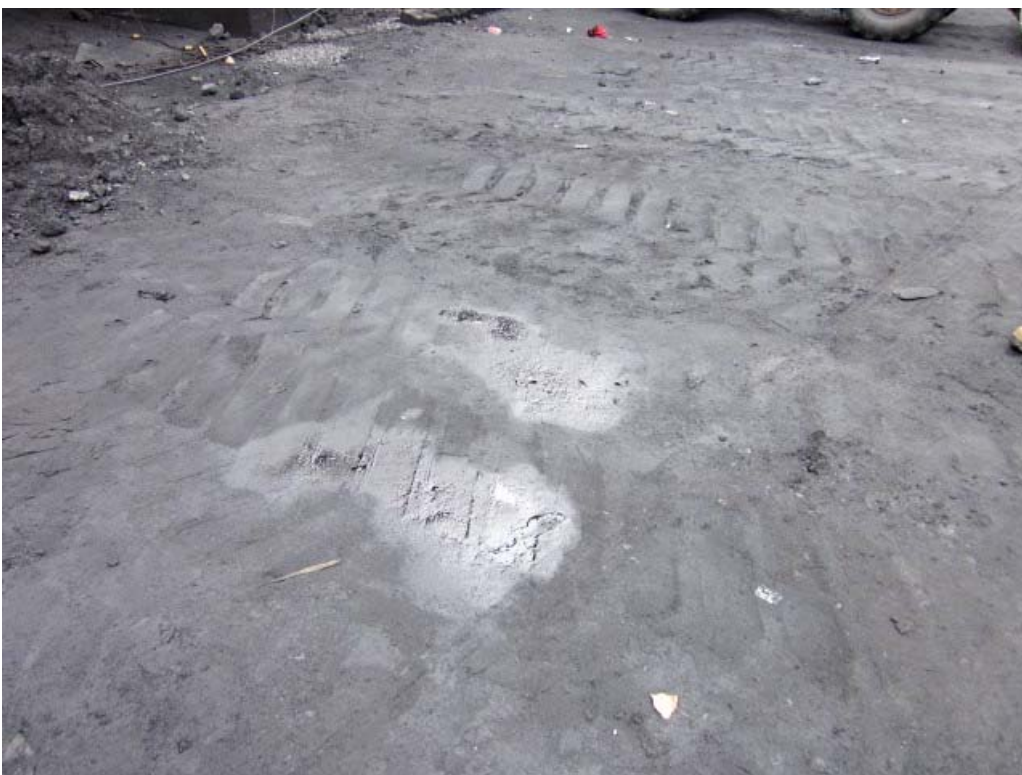
Observation: Only one piece of equipment was parked in this area at the time of inspection. While no releases were noted from this specific piece of equipment, two areas were noted where petroleum had been recently released and were still visible on the surface of the fill coal/coke fine fill material (image.sp1207205.2012-11-14.8-

LoaderParkingArea.jpg & image.sp1207205.2012-11-14.8-ParkingAreaSpills.jpg).

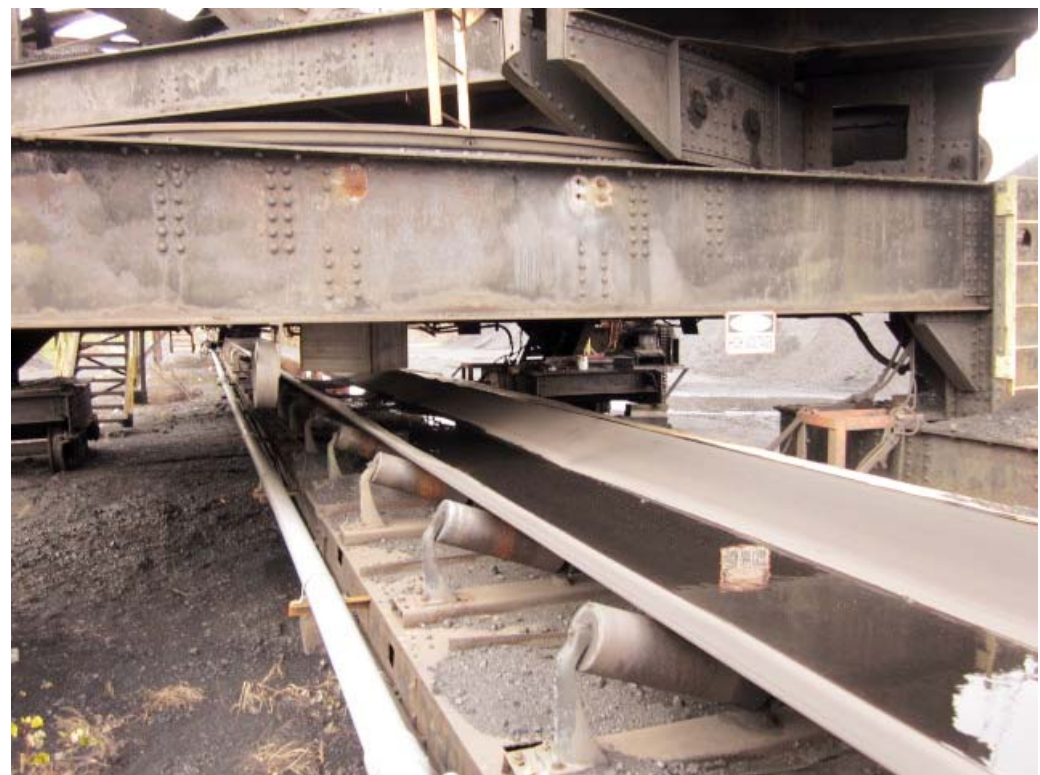
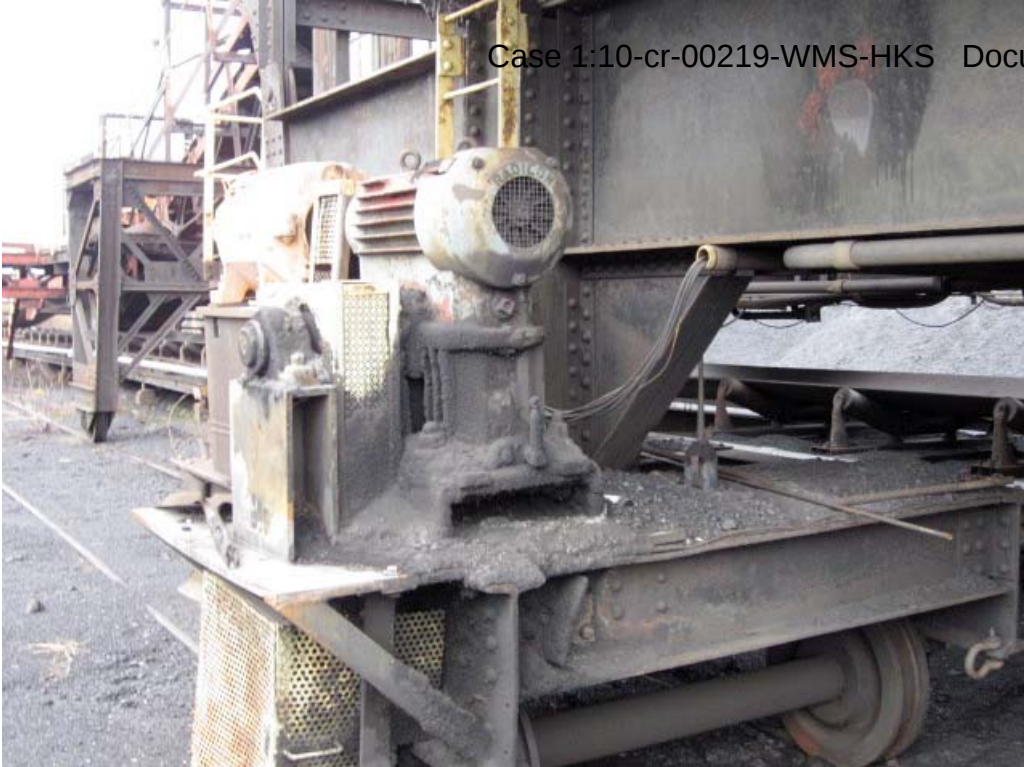
Observation: No releases to the surface were observed from this piece of equipment during the inspection (image.sp1207205.2012-11-14.9-Stacker1.jpg) TCC staff noted however that this unit has not been operated in over 3 months. However it was observed that several of the motor assemblies were caked with oily coal fines which could suggest that this unit leaks lubricating oil during operation (image.sp1207205.2012-11-14.9-Stacker2.jpg).
